**Federal Aviation
Administration**

ADVISORY CIRCULAR

AVIATION MAINTENANCE ALERTS

**ALERT
NUMBER
362**

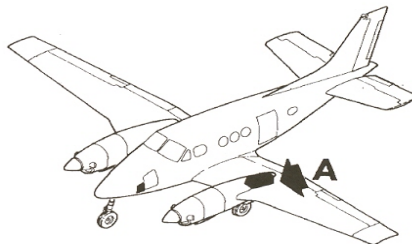
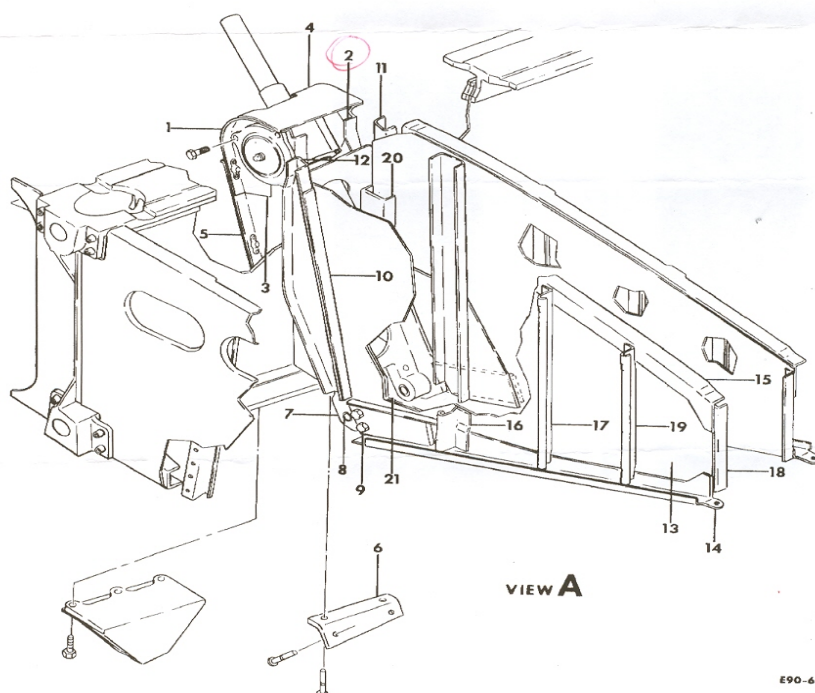
E90-63-7

Beech: C90; Cracked Drag Leg Support Brackets; ATA 5740

A repair station technician states, "The drag leg support brackets (*P/N 50-120077-16 & -17*) were found cracked on both left and right sides during a routine inspection. (*These*) cracks are most likely (*caused*) by fatigue or a rough landing."

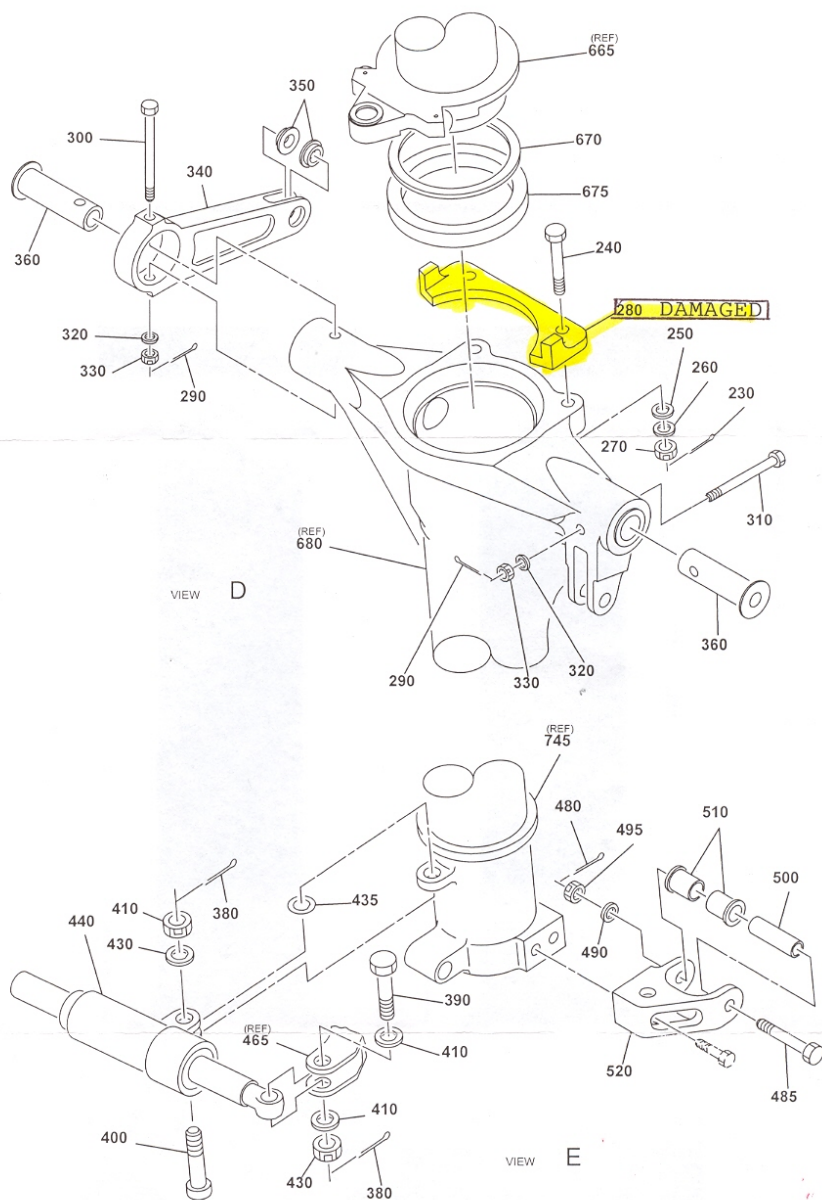
32-20-10-01

A technician describes an all too frequent problem for many airplanes. “The pilot reported (*having*) a ‘landing gear unlocked’ indication after selecting gear retraction (*subsequent to*) takeoff. We found the nose gear stopper assembly damaged, preventing the gear assembly from centering and (*properly*) engaging the uplock assembly. The stopper assembly was replaced after gear disassembly and inspection—gear operations then (*checked*) normal. It was reported this aircraft was previously towed with the nose gear torque links connected. The flight crew, ground operations personnel, and technicians should be aware of correct Premier towing procedures as specified in the 390 Maintenance Manual, section 9-10-01-201.” (*Stopper Assembly P/N: 390-820001-0001*)

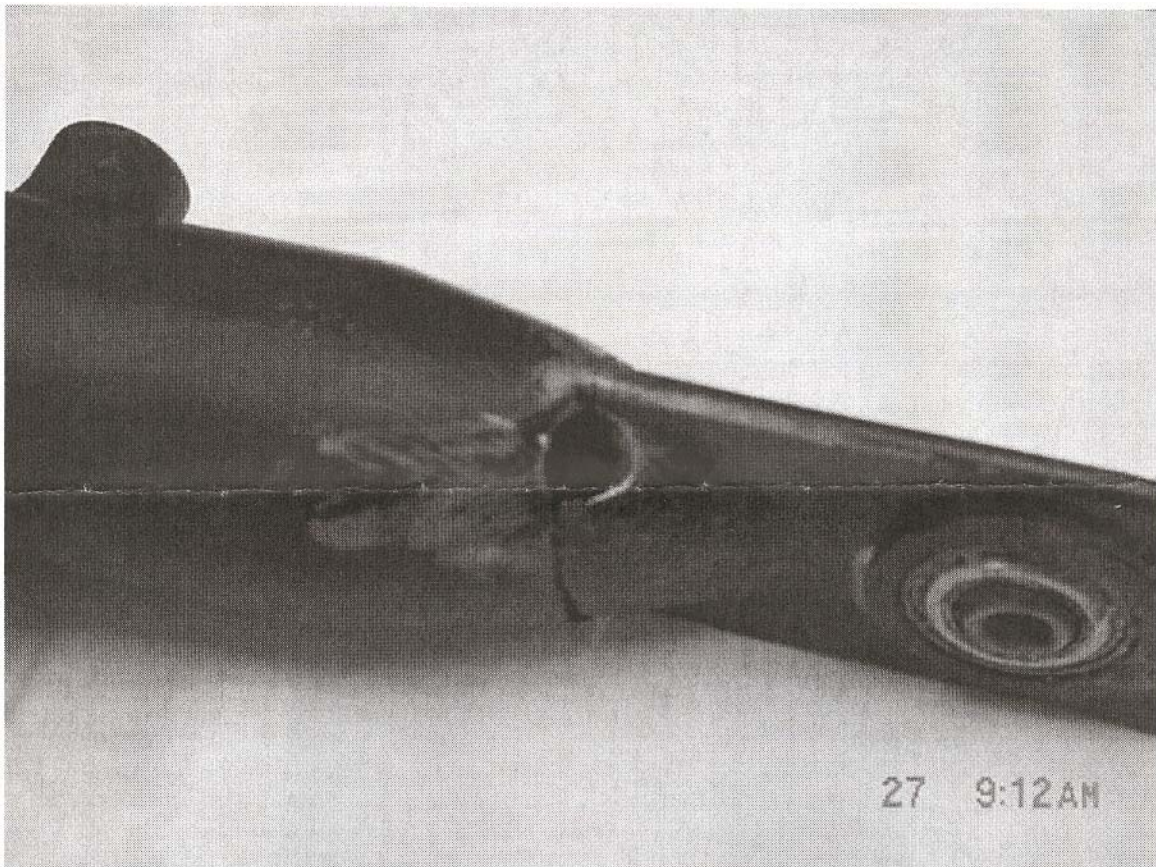
"The safety recommendation was issued because of a reported failure of a control yoke that was found while complying with the service bulletin on a 1985 Cessna 172P in Anchorage, Alaska during April 2008. As shown in the photograph, the drain hole appears to be larger than ¼ inch diameter and is mislocated. The correct position is shown in the enclosed Figure 1 from page 11 of SEB01-3R1. The FAA has determined that this alteration from the service bulletin weakened the tube structure, and may have contributed to the failure.

"For additional information on maintaining the control yokes, we suggest that you review the FAA Special Airworthiness Information Bulletin (SAIB) CE-04-03, Cessna Service Bulletin SEB01-3R1, and the article published in the Cessna Pilot Association (CPA) in September 2002 on pages 6308 through 6311 entitled 'CPA Comments to the Airworthiness Concern Sheet dated 5/31/02'."

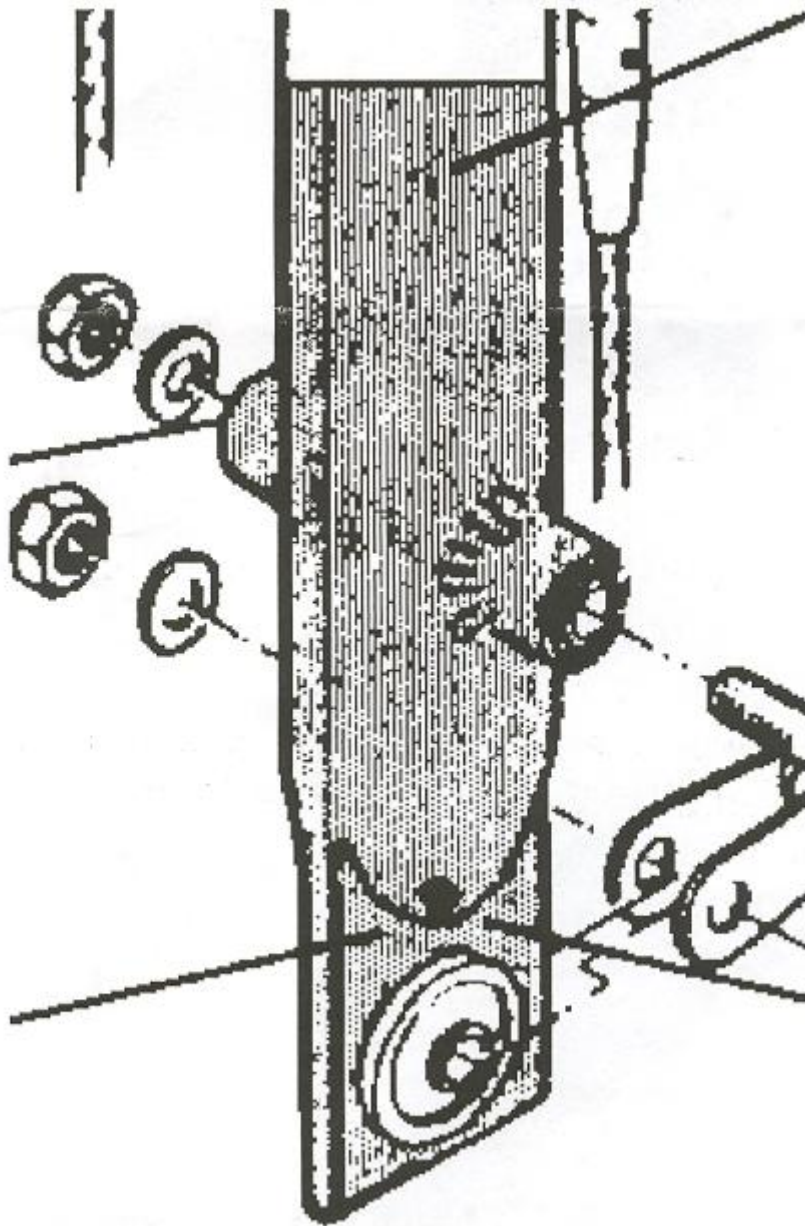
Figure 1. Control Yoke Inspection

"The FAA recently proposed in a safety recommendation to issue an Airworthiness Directive to comply with Cessna SEB01-3R1. The purpose for this service bulletin is given as follows: 'Reports have been received of some control yokes corroding internally resulting in failure of the control yoke below the pivot attach point. The control yoke shall be inspected, and if required, replaced as described in this service bulletin. Non-compliance with this service bulletin may result in failure of the control yoke which could cause complete loss of elevator control.'
